Technical Report No. 51

**A pilot study to evaluate the use of
electronic monitoring on a
Bering Sea groundfish factory trawler**

Howard I. McElderry, Rhonda D. Reidy, and Dale F. Pahti

*Archipelago Marine Research Ltd.
Victoria, BC Canada*

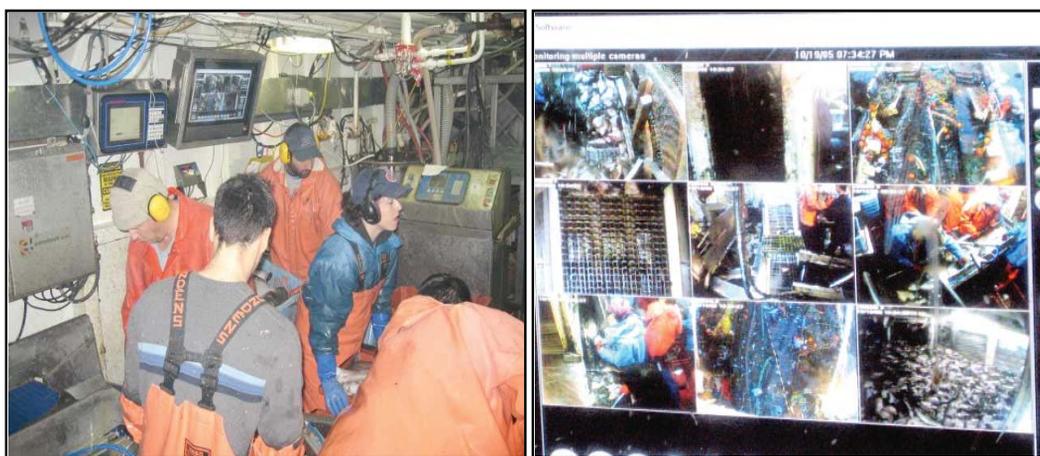
Imagery from the CCTV cameras was displayed live using a waterproof 24-inch (60-cm) LCD colour display screen mounted in the sampler/observer workstation (Fig. 4). The monitor provided views of all cameras as a composite, or larger size views of individual cameras. Remote control of the display and DVMS unit at the observer sampling station was through a waterproof keyboard, interfaced with a networked laptop PC (Fig. 2).

Figure 4. LCD screen available to crew in sorting area (left) and close up photograph of the LCD screen showing nine camera views simultaneously (right).

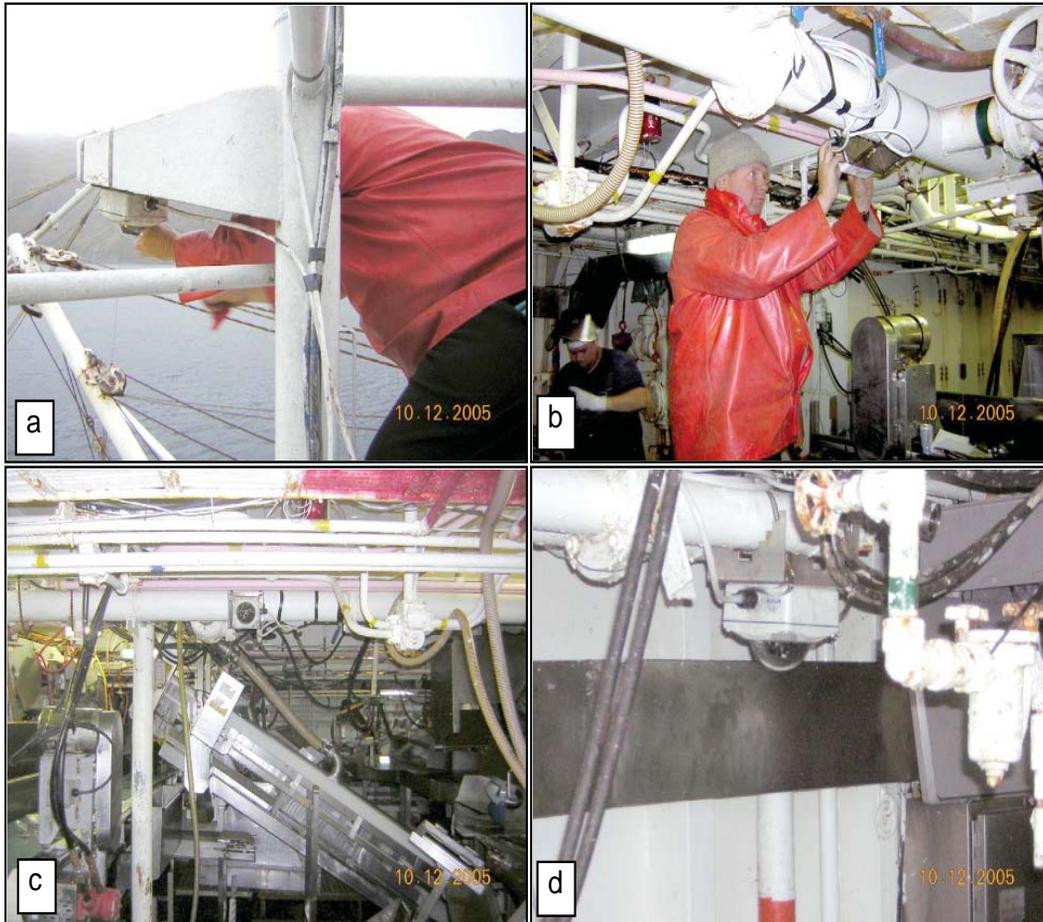
A total of nine CCTV cameras were installed in all fish handling areas, providing a full view of the trawl deck and closer views of the interior fish tanks, factory conveyor belts and discard lift conveyors (Fig. 5).

Figure 5. Camera installations on the deck gantry (a) and in the factory's starboard discard area (b), and cameras mounted in the port discard area (c) and over the flow scale conveyor (d).

Cameras were installed in key locations; with image capture rate set at 2 frames per second for the two gantry cameras, and 5 frames per second for the seven cameras in the factory. Gantry cameras were intended to monitor sorting on deck and not speciation of catch; therefore frame rates were set lower on these cameras to increase available recording time on the hard drives. Each camera was individually wired directly to the DVMS located on the engineer's storage shelf on the starboard side of the vessel (Fig. 6). The GPS data logger was also located with the DVMS unit.

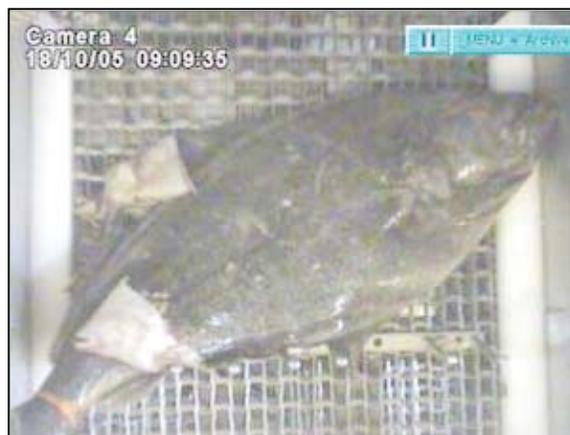
the factory, individually tagged halibut were tracked through the factory sorting process to the point of discard. Four halibut from each haul were measured, individually marked with either a blue, yellow, pink, or orange nylon cable tie wrapped around the caudal peduncle (Fig. 9). Due to the difficulty in obtaining halibut prior to sorting, halibut were obtained from previous hauls, tagged, and added to unsorted catch in the fish tank immediately following the dumping of succeeding hauls. The on board video technician recorded the time when marked fish were added to the fish tank.

Figure 9. Halibut with orange nylon tag moving up the port discard lift conveyor.

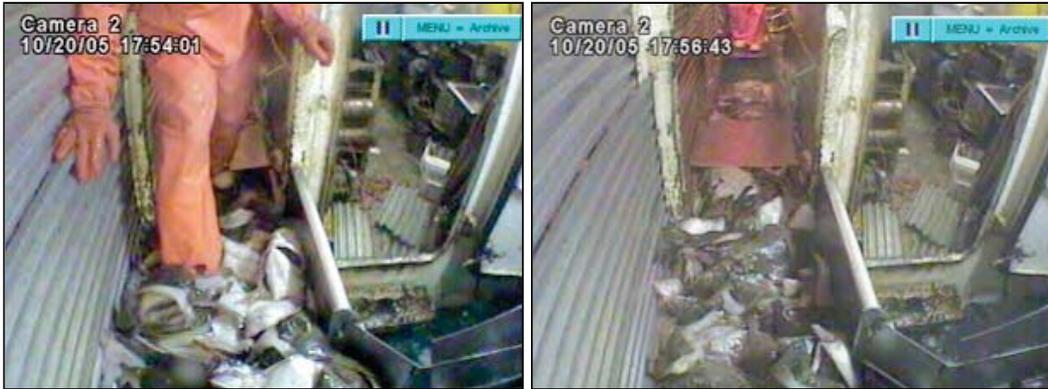
Initial CCTV camera placements were made without the benefit of fish moving in the factory, so it was expected that repositioning would be necessary when the factory was in full operation. One such change involved relocating the starboard-side tank camera to a position where crewmen could be observed feeding fish from the tank onto the first lift conveyor (Fig. 11). It was then possible to better monitor the potential for crew bias of the sampling process by holding back selected species.

Figure 11. Adjusted fish holding tank camera view, showing kicker feeding unsorted catch onto the first lift conveyor belt (compare with Fig. 8c).

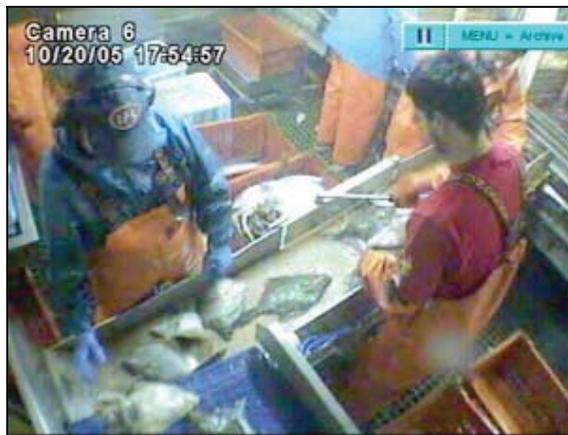
CCTV camera positioning on the flow scale was based on the notion that the faster speed of the belt would spread catch and improve presentation of individual fish. However, early viewing of flow scale imagery revealed that the color of the conveyor belt (blue/black) made species identification difficult, and there was still some overlap of fish that further limited identification. To improve species recognition and to monitor crew handling of prohibited species, the flow scale camera was re-positioned to capture the end of the flow scale where fish dropped onto the sort conveyor, and included most of the at-sea observer station (Fig. 12).

Figure 12. Modified flow scale camera view, showing unsorted catch transferring from the flow scale to the sort conveyor belt at the observer work station (compare with Figure 8f).

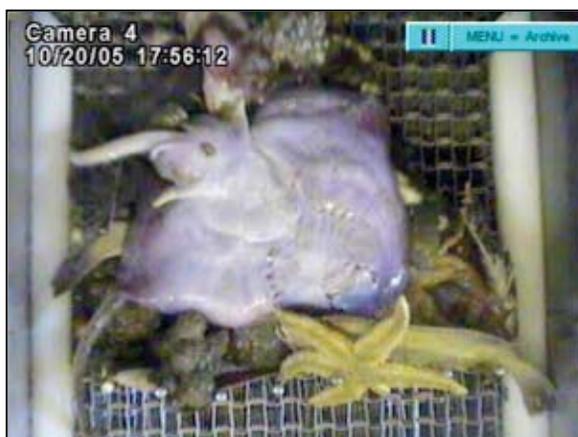
carrying out their normal duties regularly obstructed the view. The camera was repositioned directly above the port lift conveyor with a close up view of the conveyor. This change more clearly resolved individual discard items and eliminated the potential for crew obstruction of the view (Fig. 13).

Figure 13. Adjusted port discard lift conveyor camera view, with discarded catch and processed pieces moving up the lift to the discard scupper (compare with Figure 8h).

As well, the port discard camera also required changing from a wide field of view, covering the horizontal discard conveyor and the discard lift conveyor. This change was necessary as crew

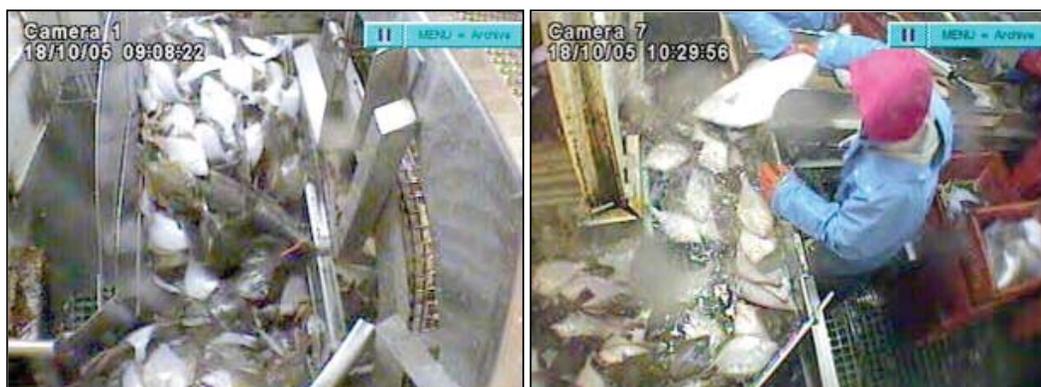
The first lift conveyor was inherently difficult to monitor for tagged halibut because fish piled and slid back as the belt lifted fish to the top of the conveyor (Fig. 14, left). As a result, single tagged halibut were difficult to detect within the tumbling mass, and viewing was often complicated by moisture on the camera dome. Imagery from the sort area camera (Fig. 14, right) could easily distinguish tagged halibut, although the view was obscured by moisture on the camera dome and by crew working in the field of view sorting catch.

Figure 14. An orange-tagged halibut mixed in with unsorted catch on the first lift conveyor (left), and crew handling a tagged halibut at the sort area (right).

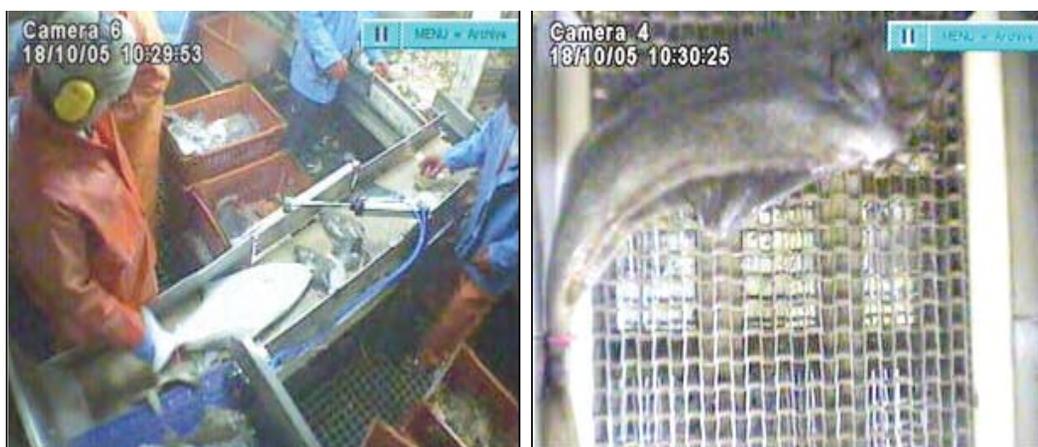
In contrast, the cameras monitoring the flow scale/observer station (Fig. 15, left) and the port discard lift conveyor (Fig. 15, right) were generally very good for the entire cruise. Halibut detection was relatively uncomplicated in either view, and these cameras were less prone to moisture accumulation on the camera dome.

Figure 15. A pink-tagged halibut in the flow scale/ observer station (left), and the same pink-tagged halibut moving up the port discard lift conveyor (right).
